Voluntary Field Correction

We have recently learned that incorrect placement of AA batteries into certain LeadCare® Blood Lead Analyzers may cause the batteries to overheat, and there is a chance that a user could burn their fingers if the batteries are removed while hot.

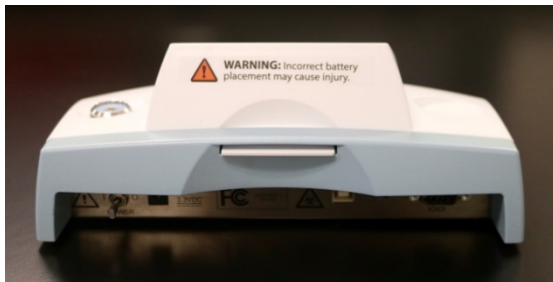
The LeadCare® II and LeadCare Plus® Analyzers are powered either by wall outlet or by four 1.5 V size AA alkaline or lithium batteries. If two of the four AA batteries are inserted incorrectly (the positive and negative ends of the batteries face the wrong directions), the batteries may overheat. This could cause a minor burn if the user opens the battery compartment and tries to remove the batteries while they are hot.

1. Remove the battery cover and follow the instructions and markings for proper battery placement. Batteries should NOT be stored in the analyzer if battery power is not being used.
2. Magellan Diagnostics is sending reminder labels to each customer. Place the label(s) on the upper back panel of the analyzer(s) to remind users who are changing batteries of the importance of correct placement. Change batteries in a well-lit area.
